Rocket Propulsion Testing at NASA's John C. Stennis Space Center

E-1 Test Stand Mishap

**Rocket Test Facility Operators
Working Group
April 20-21, 2005**

E1 Test Stand Mishap/Fire

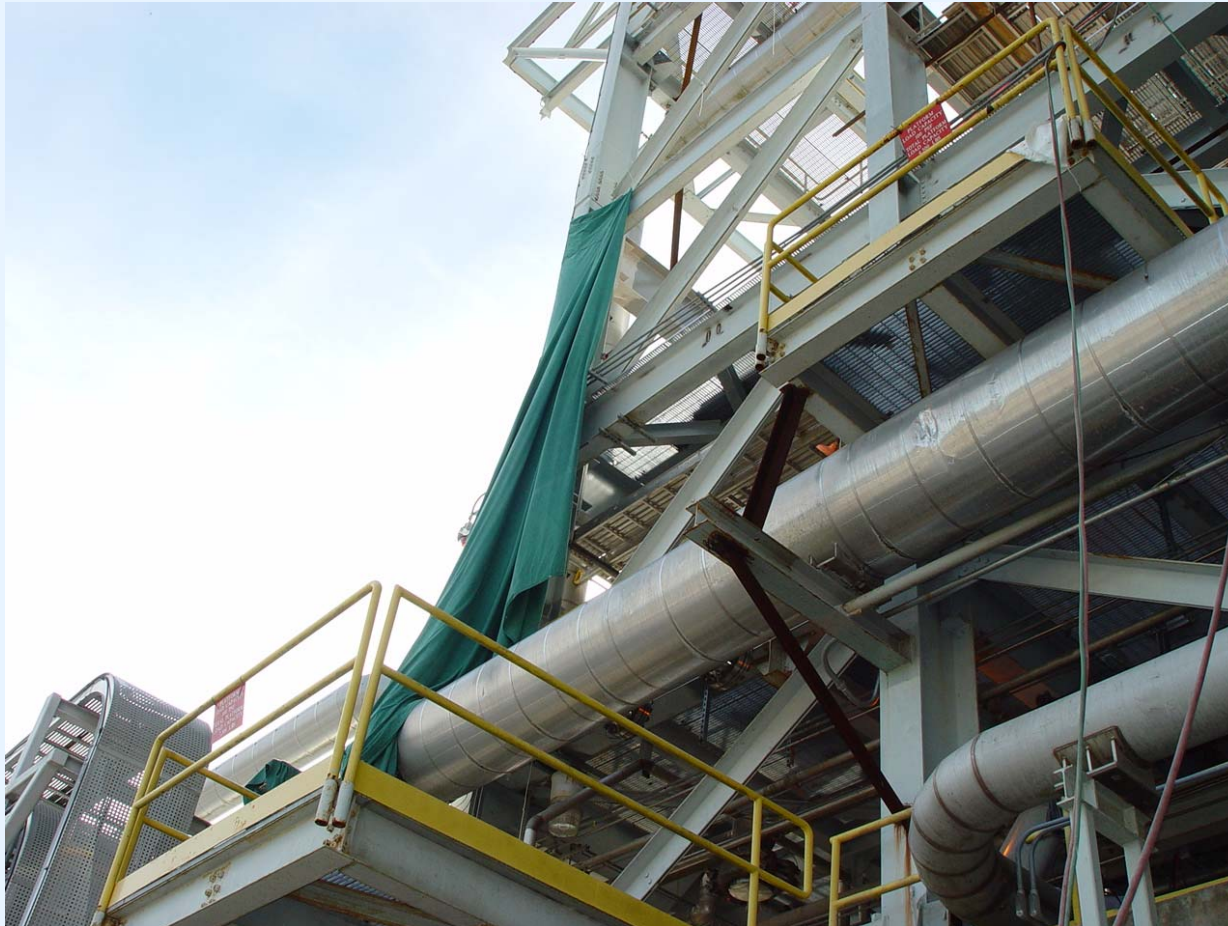
Green Tarp used as wind break

Finding # 6: Inappropriate tarps were used for a windbreak at the site of the E-1 Test Stand welding operations.

Rationale: The tarp material was analyzed at SSC's Material Analysis Laboratory and offsite at Southwest Research Institute and the material was determined to contain significant amounts of diesel fuel. The tarp material is considered to be highly flammable.

Recommendation # 6: Specifically with respect to the tarps, immediately stop using the tarps in enclosed areas and in locations where hot work operations are taking place.
